**National Interagency Prescribed Fire Training Center and Florida
Division of Forestry Flagler County, ATV Incident on Units 26 and 32
February 21, 2005**

National Interagency Prescribed Fire Training Center and Florida Division of Forestry ATV Incident on Units 26 and 32 on February 21, 2005

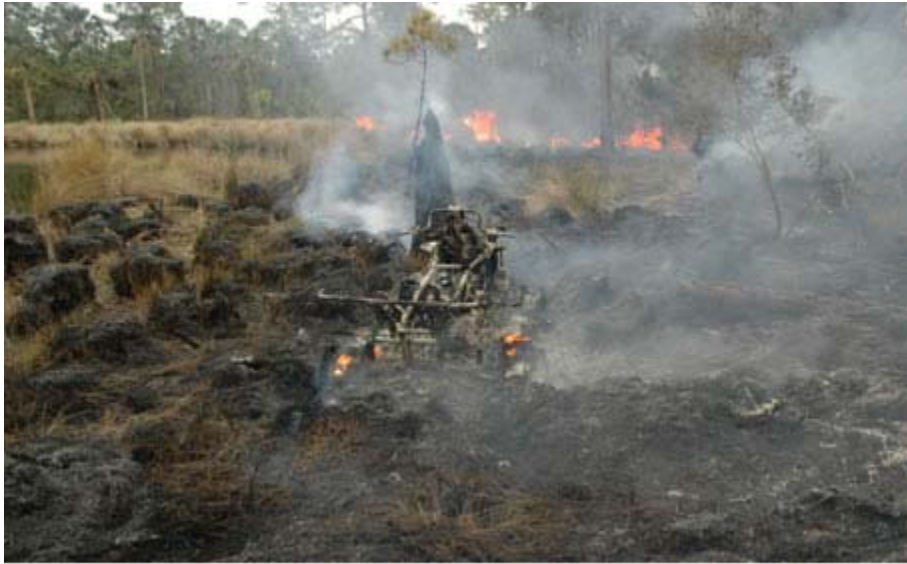
Site of ATV accident in which an ATV was destroyed by a prescribed fire. Flagler County, FL 2/21/2005. Photo by: Keith Hackbarth, BLM, Boise, ID.

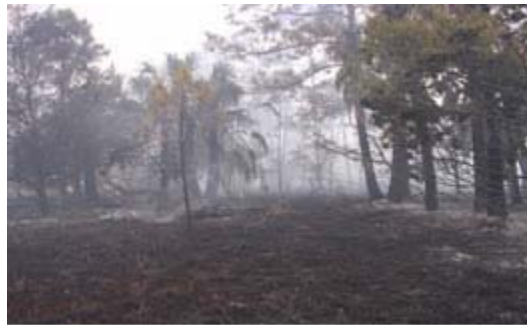
Firm ground condition in Pine/Grass, Fuel Model 2, adjacent to the site where the ATV became mired. Photo by: Keith Hackbarth, BLM, Boise, ID.

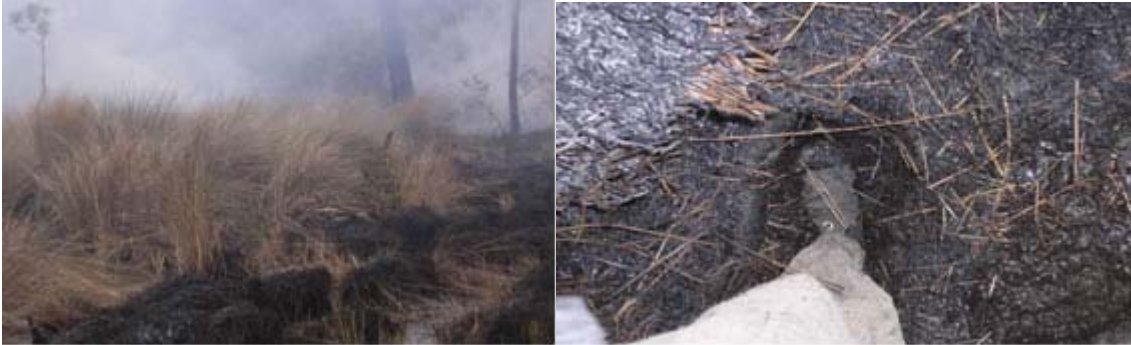
1410 After reaching the northeast edge of the pond the operator decided to continue burning around the pond back to the west. After only going 20 yards from his ignition point the ATV became bogged down in the edge of the swamp that was hidden from the operator view by the tall and laid over grass.

1. Unfamiliarity with the terrain, and terrain conditions. The terrain along the coastal marsh is difficult, at best, transitioning from sand that will easily support a vehicle to mud that will not support a person in only a matter of feet. The area is basically flat terrain. The operator walked the site, observed the conditions, discussed them with locals, but had an inadequate knowledge of the hazard.
2. Vegetation cover associated with terrain and water characteristics. With minimal experience in Florida fuel types the operator did not know the grass in front of him grew in standing water or wet muck. The operator failed to see and avoid the hazard.

Pine/Grass Fuel Model 2 at the site of where ATV became mired. These wet boggy areas are scattered throughout the more extensive Pine/Palmetto/Gallberry, Fuel Model 7, type. Photos by: Keith Hackbarth, BLM, Boise, ID.

1. The ATV was being used to traverse the burn unit. The operator could have parked the ATV in a safe location, fired the line by hand, then returned to the ATV and moved on. This alternate action could have prevented the ATV from becoming mired and at risk to the advancing flames.

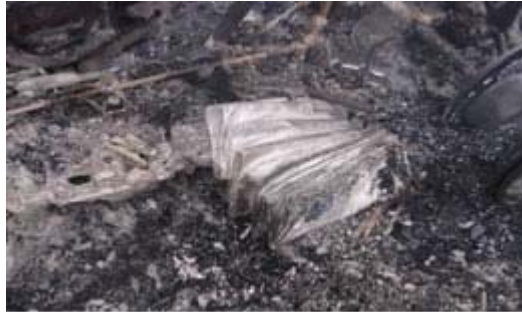
4. While attempting to free the ATV the Operator's fire shelter was getting in his way, so he removed it as he worked. As the intensity of this situation developed and it became apparent that he needed to leave, the operator headed out to the north to his safety zone without his fire shelter. He left an essential piece of safety equipment that was intended for use in just such an emergency situation. This was an error in operator judgment that could have had tragic consequences.

Remains of ATV operator's fire shelter which had been removed and set upon the ATV while attempting to dislodge the mired vehicle. The operator moved to safety ahead of the advancing flames. Photo by: Keith Hackbarth, BLM, Boise, ID.

1. Never remove or leave or Personal Protective Equipment (PPE)! As the intensity of this situation developed and it became apparent that he needed to leave, the operator headed out to the north to his safety zone without his fire shelter. He left an essential piece of safety equipment that was intended for use in just such an emergency situation. Nation-wide fire training emphasizes that the fire shelter is to be worn. This was an error in operator judgment that could have had tragic consequences.

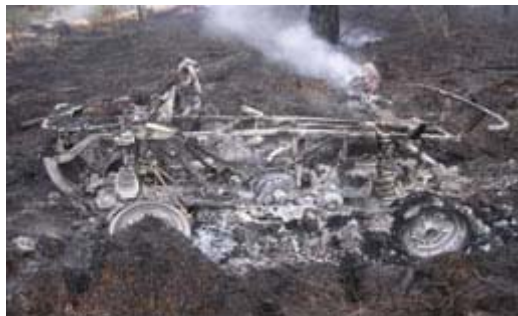
3. The ATV was being used to assist in the firing of the interior of a prescribed burn unit. There is an inherent risk to working the interior of a burn unit. Personnel or equipment working within the unit must be safeguarded and supported. The ATV was not equipped with a water tank, fire extinguisher, fire tool or winch. The Job Hazard Analysis used by NIPFTC indicated that when a vehicle and operator are exposed to fire during operations that as a minimum a 5 lb A, B, C fire extinguisher with UL rating 3A:40B:C is required to be mounted on the ATV, and that ATV's used for firing must have a minimum 5 gallon water spray rig and a winch mounted on the vehicle. The presence of these items could have been useful in protecting the ATV from the flames after it became stuck. The ATV was used contrary to the guidance of the Job Hazard Analysis.

Burned out carcass of ATV at the site of the accident, Flagler County, FL 2/21/2005. Photo by: Keith Hackbarth, BLM, Boise, ID.

3. NIPFTC Policy needs to be revised to incorporate the Job Hazard Analysis protections. Future safety briefings should address the specific Job Hazard Analysis.

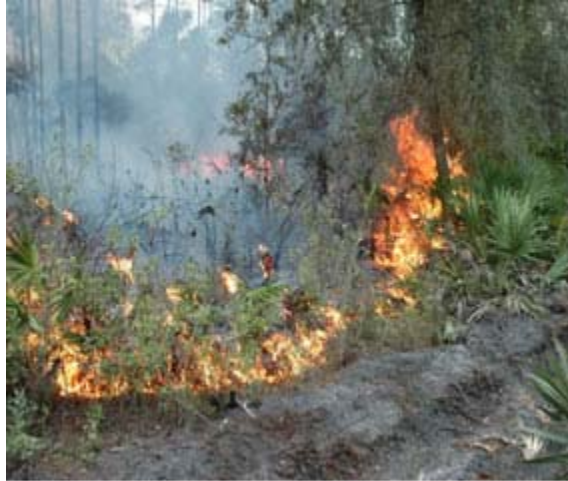
Vegetative conditions within Pine/Palmetto/Gallberry, Fuel Model 7, Flagler County, FL
2/21/2005. Photo by: Keith Hackbarth, BLM, Boise, ID.
