New York Peak Fire Burnover
July 25, 2006
Factual Report

Table of Contents

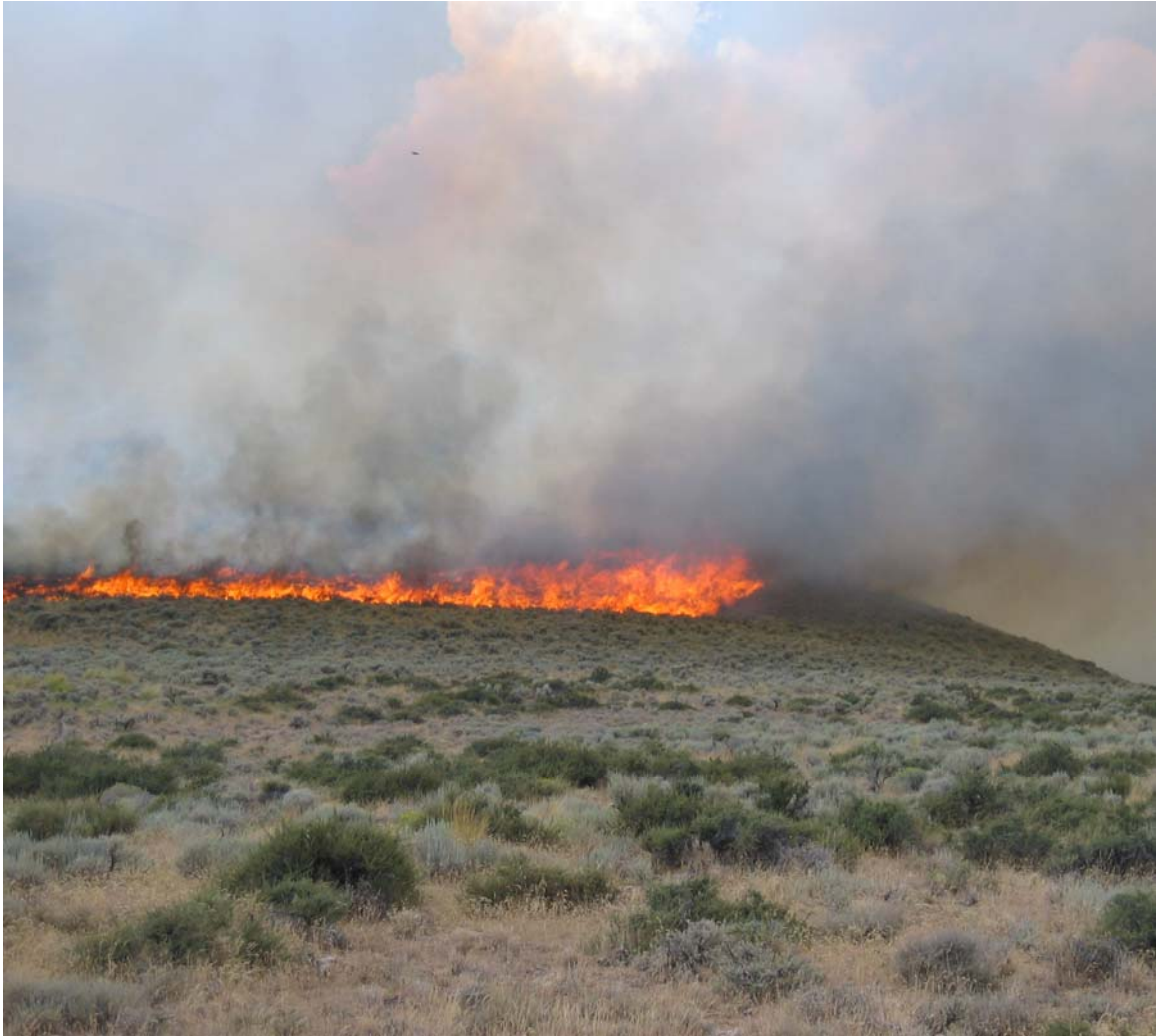
Typical fire behavior when wind shifted creating a head fire. Fire moving towards road to the east.

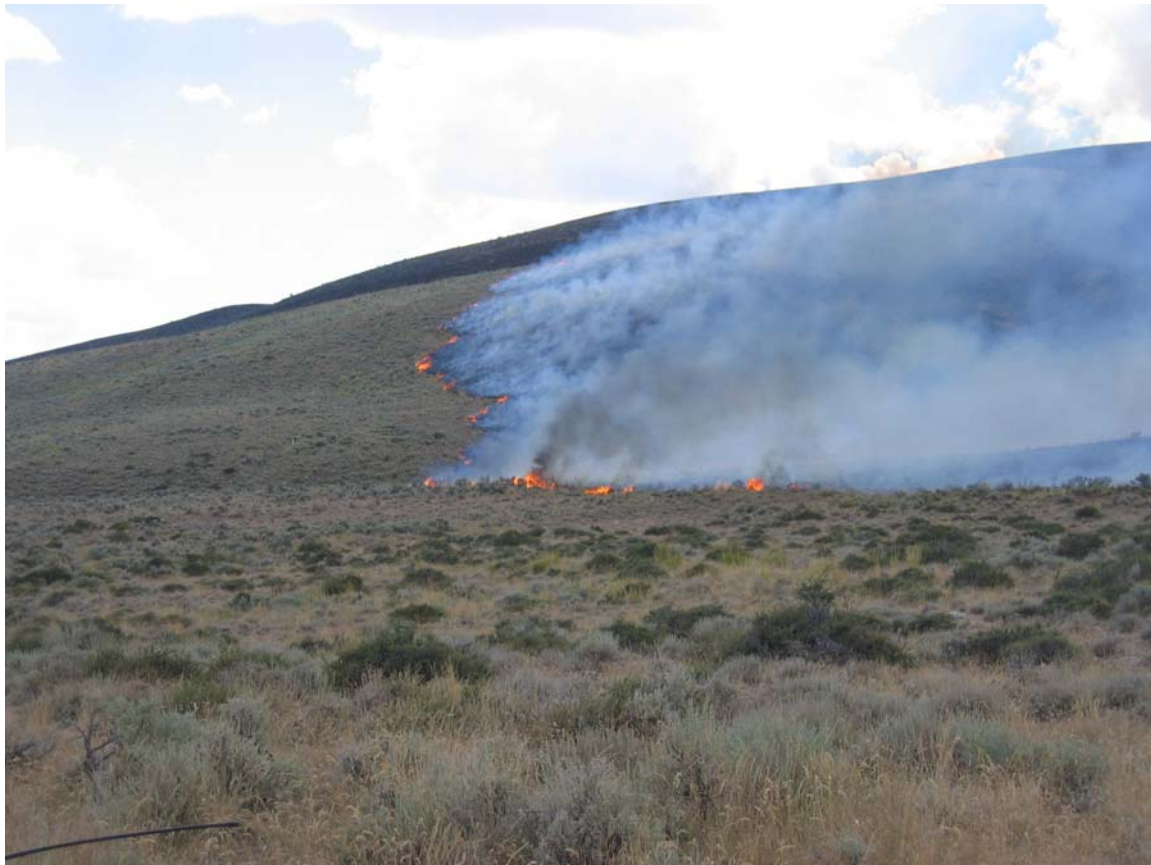
Typical fire behavior when fire was backing towards road. Wind blowing uphill to the west. Fire backing towards road.

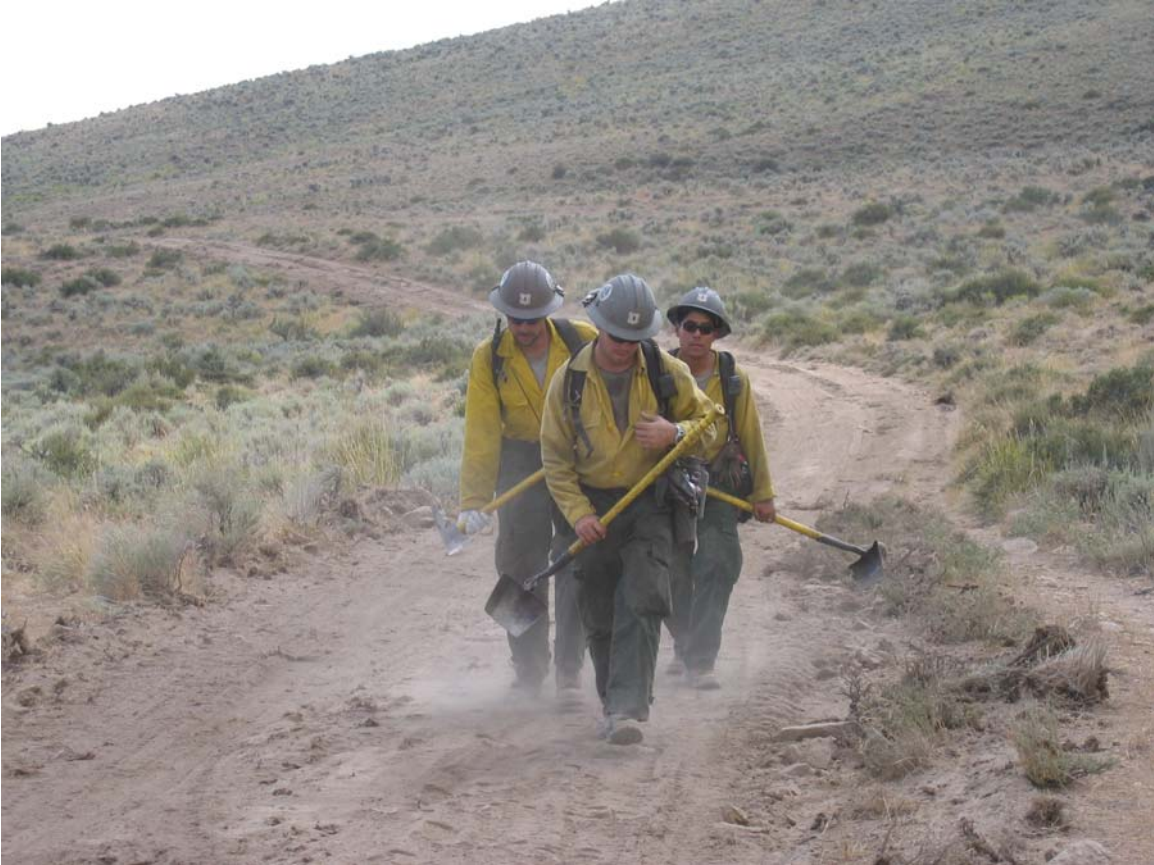
The area to the left of personnel is where spot fire #1 occurred. This photo shows the actual fuel that was consumed in spot fire #1.

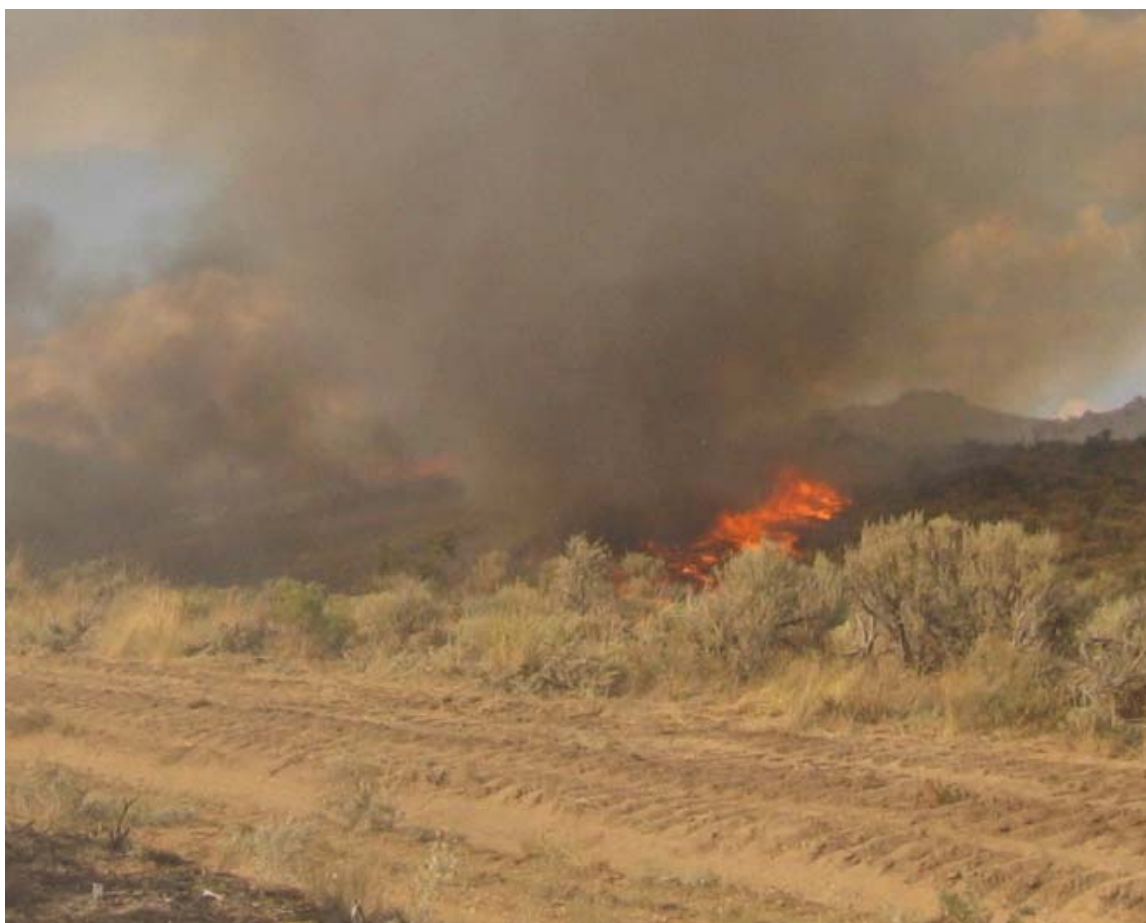
Picture taken of spot fire #1. The Eldorado IHC squad was preparing to start handline back towards road from end of dozerline. Fire was backing due to wind being from the east, southeast.

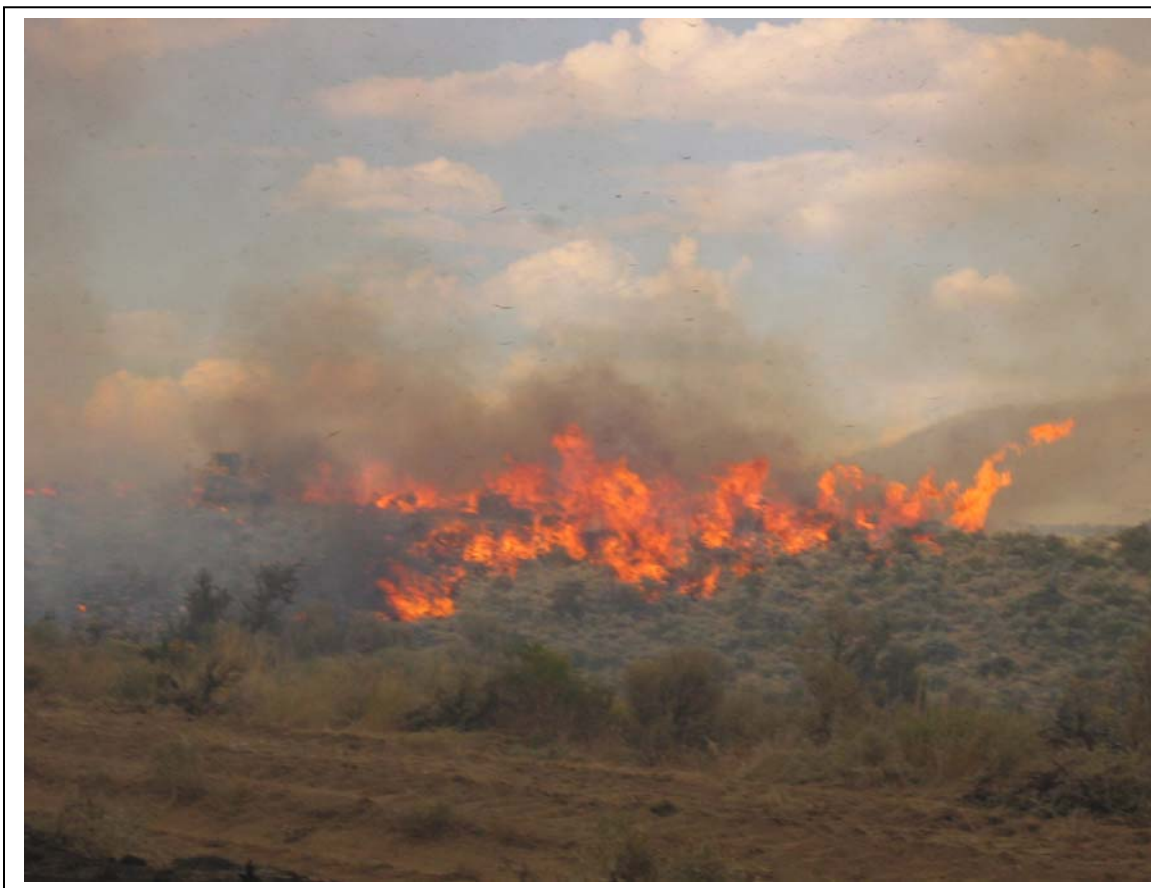
Photo taken after wind shift and fire whirl occurred. Head fire due to westerly wind.

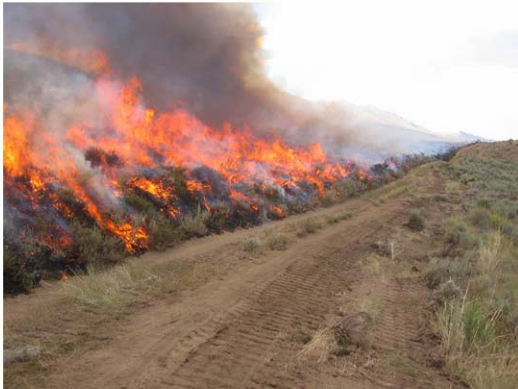
16:21:40
This image was taken roughly half way (distance wise) through the burn operation. The first spot occurred near the ridge on the far right of the image.

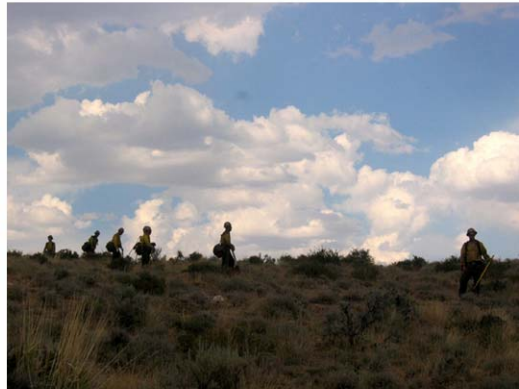
16:19:09
This image shows the typical cloud cover during the burn operation, as the crew holds the line. The same cloud cover was present during and after the spot occurred.

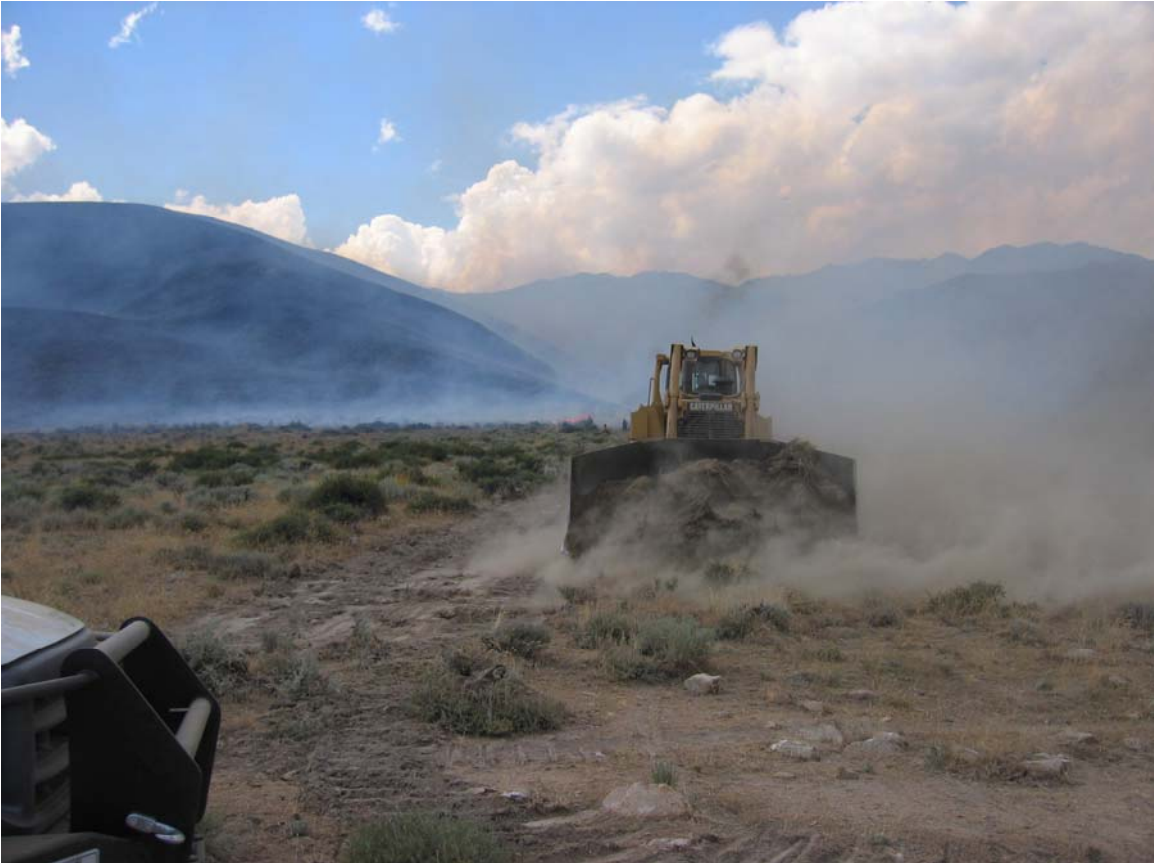
Photo taken looking to the west before the burnout took place. Notice the clouds in the back ground. Chicken Creek is to the right and the area to be burned out is to the left.

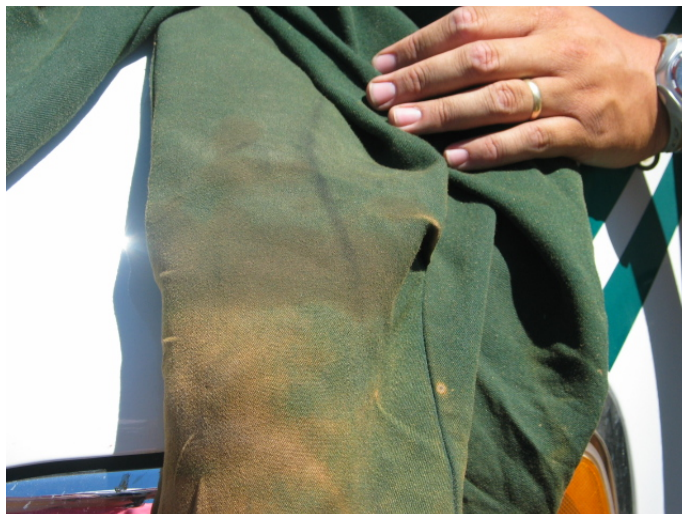
Nomex pants worn by crew member; discoloration from heat damage.

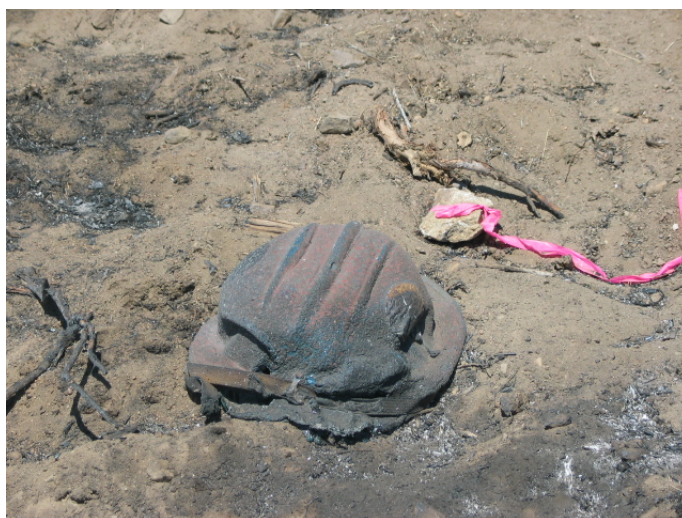
Helmet dropped by crew member; heat damage.

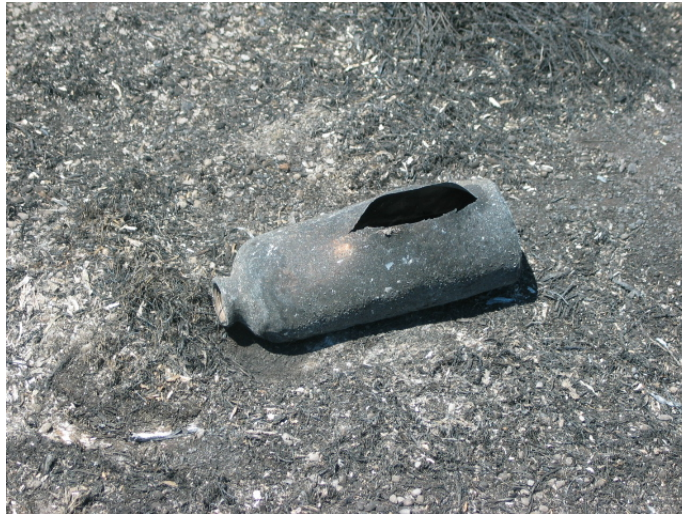
Fuel container dropped by crew member.

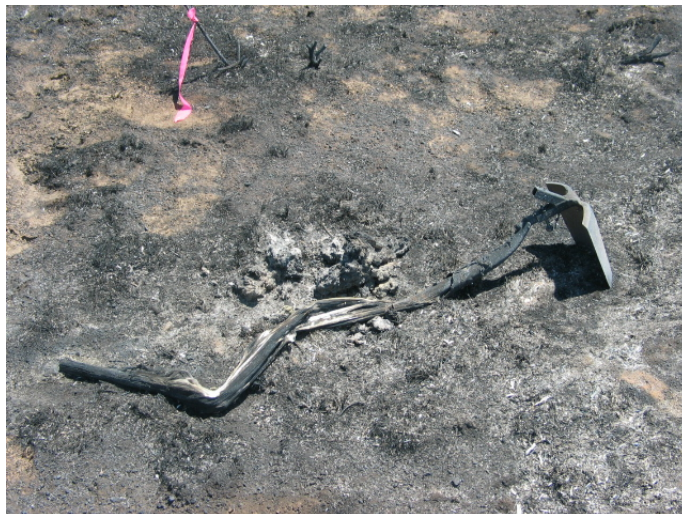
Shovel dropped by crew member; heat damage.

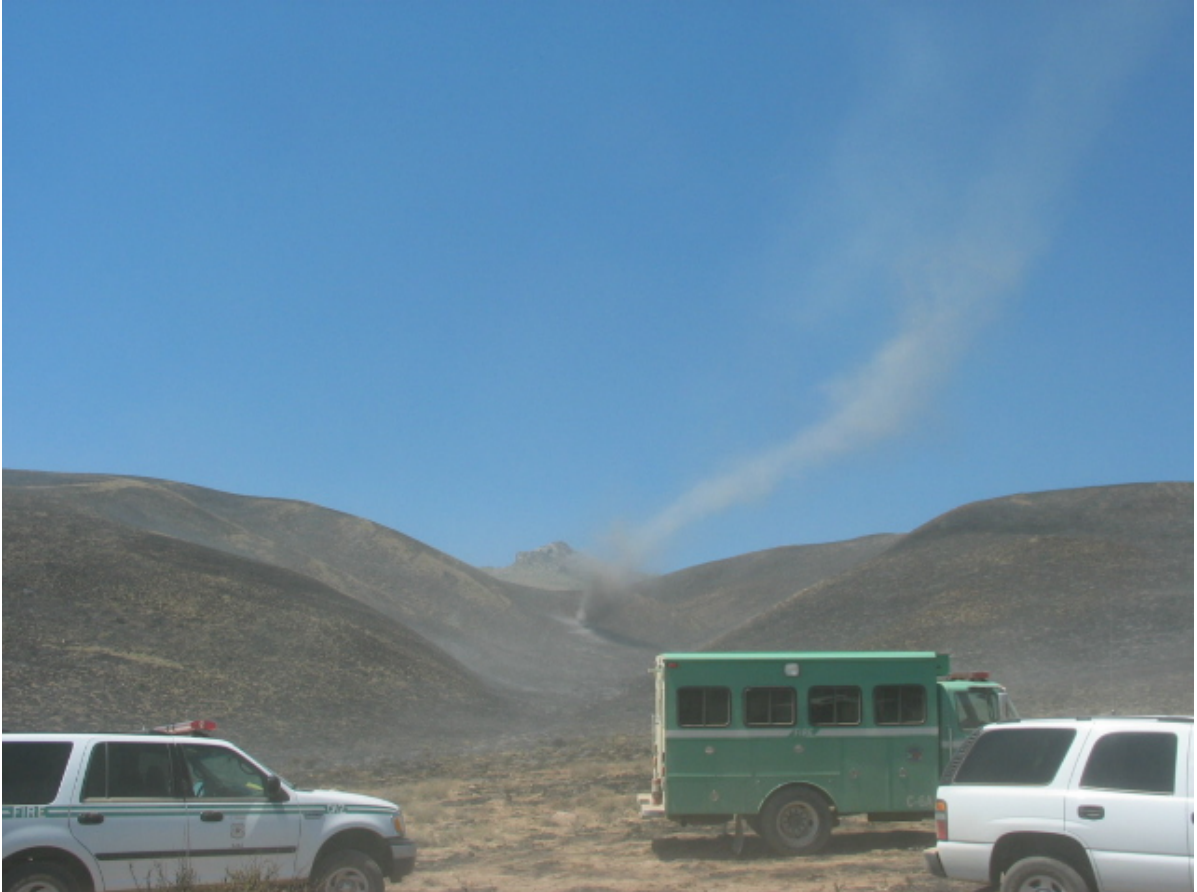
Typical dust devil forming in the draw on July 26, 2006.

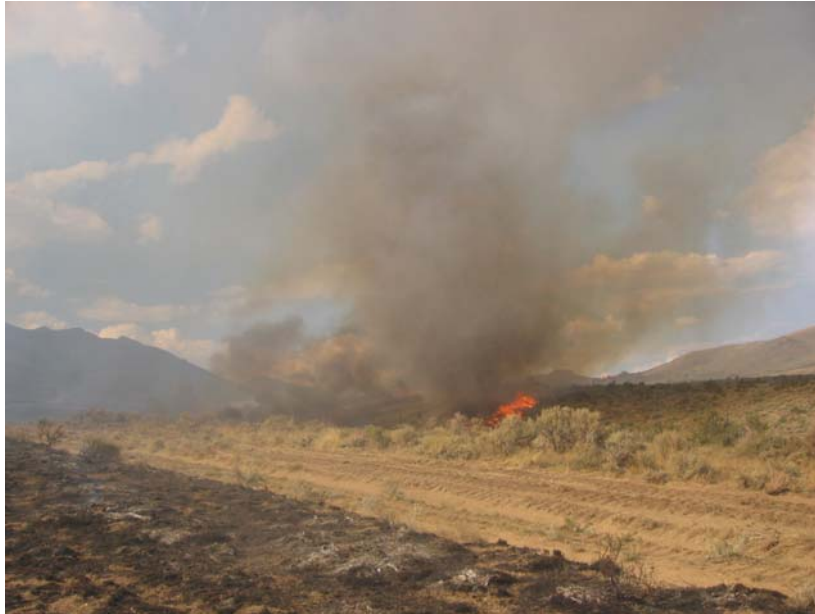
These photos were taken by crew member #1 and indicate approximate times of the fire's progression. Captions were provided by crew member #1.

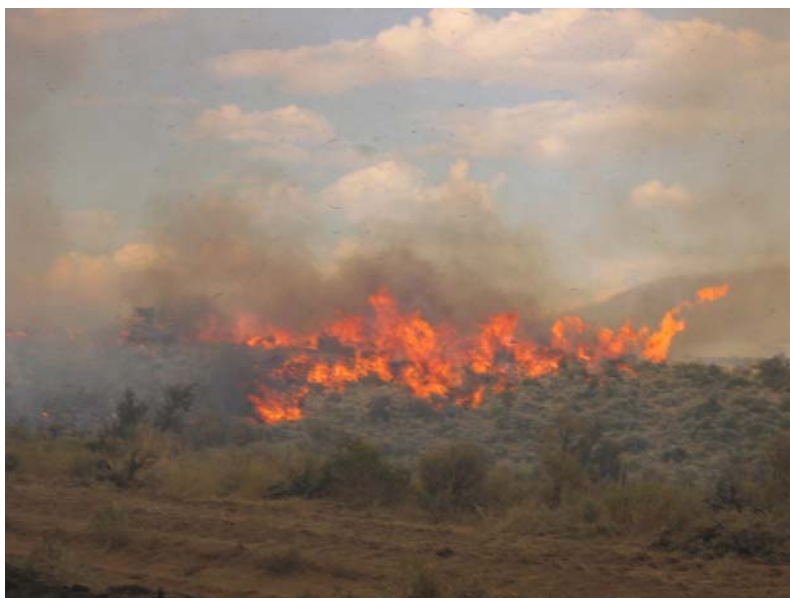
New York Peak Fire Burnover
July 25, 2006
Factual Report
