Examination of the Home Destruction in Los Alamos Associated with the Cerro Grande Fire July 10, 2000

Jack D. Cohen
Research Physical Scientist
USDA Forest Service,
Rocky Mountain Research Station
Fire Sciences Laboratory
Missoula, Montana

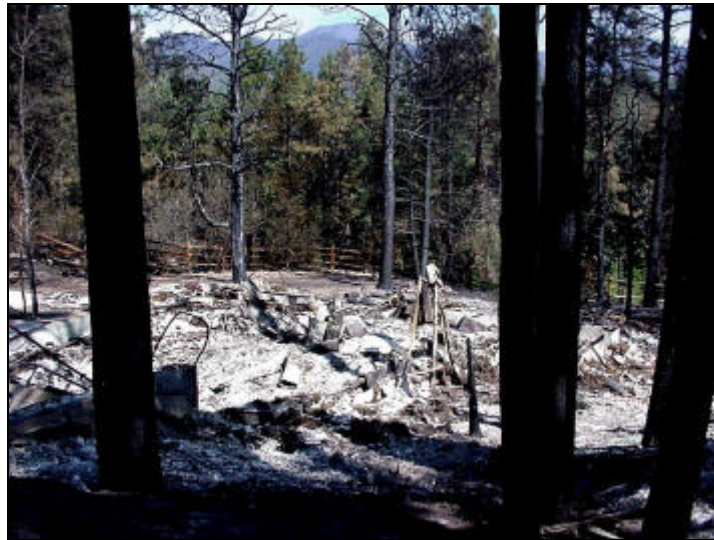
Photo 4—The unconsumed, moderately scorched tree canopy along with the remaining wood rail fence indicate that this home was exposed to a low intensity surface fire. The high intensity wildfire burned on the hills in the background.

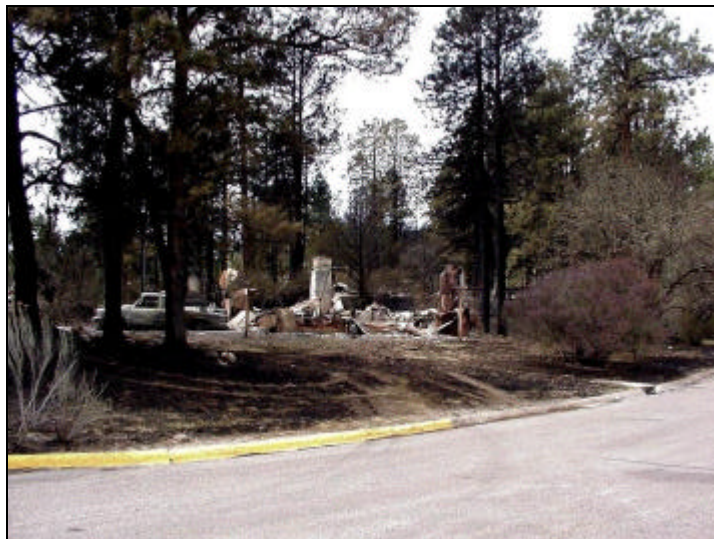
Photo 5—This totally destroyed home was within the residential area. A road separated it from other burning vegetation and homes. The unconsumed vegetation with little scorch indicates that the fire intensity surrounding the home was low. This suggests that firebrands (burning embers from other fires) ignited the home directly and/or in adjacent flammable materials that spread to the home.

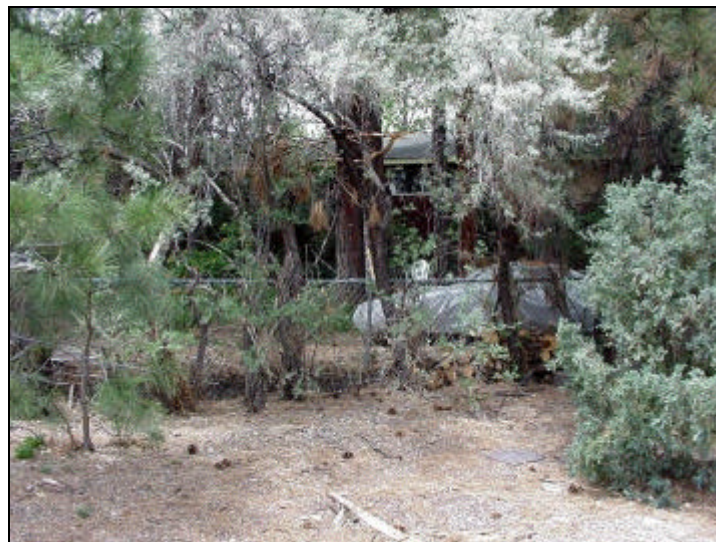
Photo 7—The tree canopy, shrubs, pine needle bed, and woodpile adjacent to and touching this Los Alamos home represents a common situation.
