In the early morning hours of Sunday, September 6, 2020, a Brush Engine from a rural fire department responded to a wildland fire. While attacking the left flank of the fire, the engine drove into an unseen gully and became stuck. The engine was immobilized in a patch of unburned fuels surrounded by black. Eventually, the engine caught fire and was destroyed. All crewmembers were able to exit the vehicle and retreat to a safe location in the black.

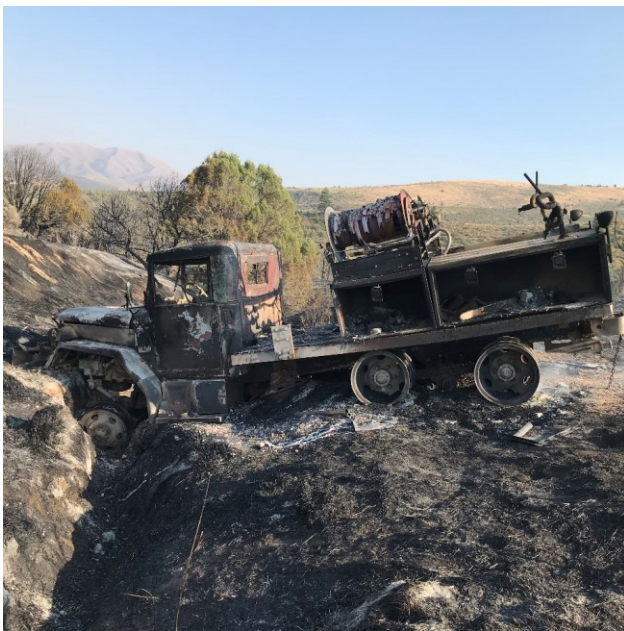
Photo 1. Brush A after burnover, stuck in the gully.

The engine lurched forward into the gully, driving the front bumper into the opposite side of the bank. The chassis behind the cab came to rest on the ground with the front bumper lodged into the opposite side of the gully. The wheels were suspended. Brush A was stuck and there was no way of getting the vehicle out without assistance.

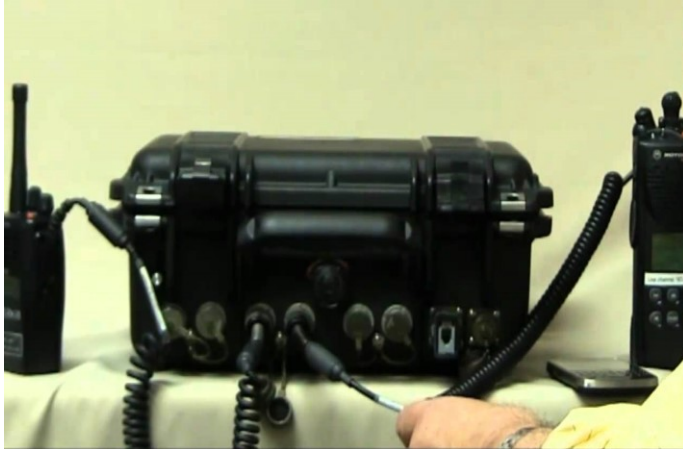
*Photo 2. Interoperability box typically used by Federal Agencies.
(Image courtesy c-at.com.)*

¹ Most Fire Departments (City, Rural, Volunteer, and other public safety entities) use the 700MHz Band. This frequency allows for signals to cover large geographical distances and penetrate most building walls whilst requiring less infrastructure. Federal, State, and Local government agencies may also use VHF (Very High Frequency) channels that are reserved for their use. Both bands require a license from the Federal Communications Commission (FCC). Because the frequencies are different, 700MHz and VHF are unable to directly communicate with one another. An interoperability box is used to interconnect the two frequencies. Each radio with a different band is connected to the box. When a signal comes in from a 700MHz radio the frequency transmission is converted to a VHF signal and then transmitted to any VHF radios on the same channel and vice versa.

Due to cost, very few Municipal departments can afford the equipment. On average each box costs about \$6000. Additionally, there must be one 700MHz and one VHF radio that can be connected to the box. Some government agencies have interoperability boxes available for use on wildland fire, however quantities are limited and are typically stored at a Fire Cache or other location and not easily accessed during initial attack if the incident is not near the storage location. The use of an interoperability box also causes a mild delay from one radio frequency to the other due to processing time.

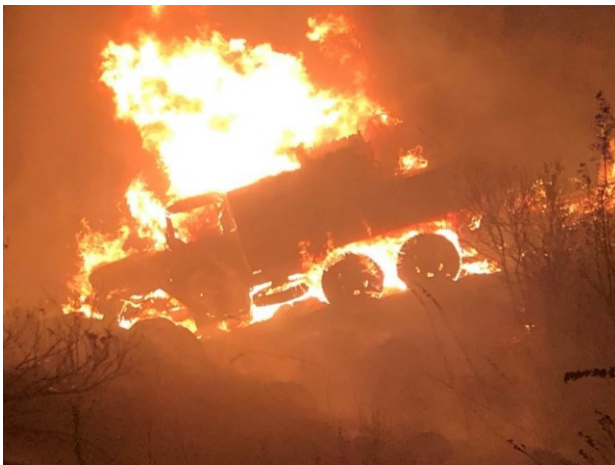
Photo 4. Brush A fully engulfed.

Within moments of arriving near Brush A’s location, Brush B noticed the mud flaps had caught fire.

Minutes later, Brush A was fully engulfed in flames. The engine exploded in a 40-foot fire ball within seconds. No crew members were near Brush A when it exploded, no personal injuries resulted.

- This situation highlights the continued communication challenges with GIFF and can serve as motivation to continue working toward solutions.
- This incident serves as an opportunity to discuss the dangers associated with pressure build-up and potential explosion of water tanks in fire situations.
- This incident can also serve as motivation to invest in pre-incident collaboration with an emphasis on common terminology. In high-tempo situations, seemingly minor differences can paint very different pictures. Interagency simulations and sand table exercises are a great tool for discovering and addressing differences.
