Rapid Lesson Sharing

Event Type: Carbon Monoxide Poisoning

Date: October 22, 2019

Location: ICP Medical Unit Yurt
Cow Creek Fire, Colorado

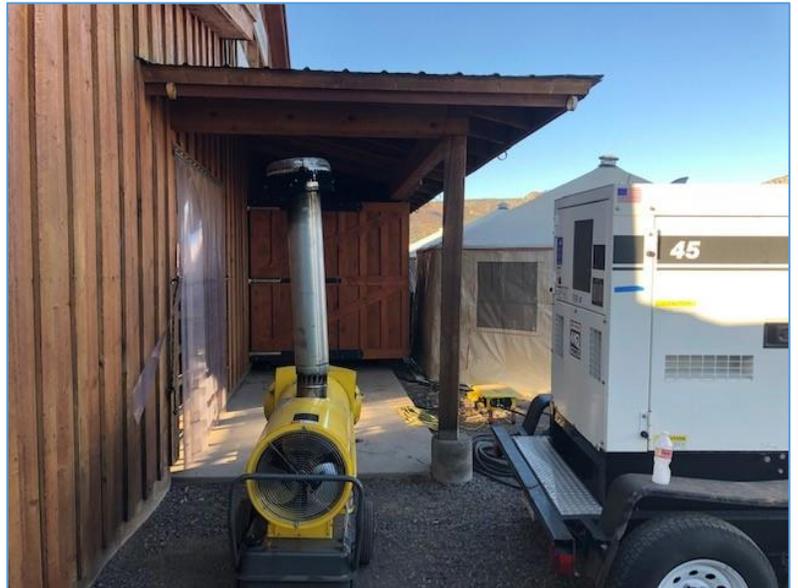
It was determined that because the (yellow) heating unit was placed next to a building with an overhanging roof, the unit's exhaust was trapped and cycled back into the unit's air intake, which was then pumped into the Medical Unit yurt with warm air. The yurt is seen on right in the distance; the generator is on right in foreground.

The heating unit was set up next to a building with a nearby overhanging roof. It appears the sinking cold night air trapped the unit's exhaust in a way that it cycled back into the unit's air intake, which was then pumped into the yurt with the warm air.

Carbon monoxide detectors are critical for early warning whenever fossil fuel burning heating units are used. Their installation may not be specified in contracts for heating units.

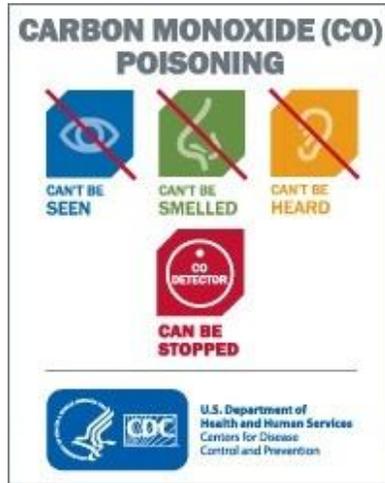
Taller exhaust stacks can better disperse harmful emissions.

The National Institute of Standards and Technology recommends setting up generators outside as far from windows, doors and vents as possible.
