Rapid Lesson Sharing

Event Type: Firefighter Burn Injury

Date: May 25, 2015

Location: Willow Peak Fire,
Nevada

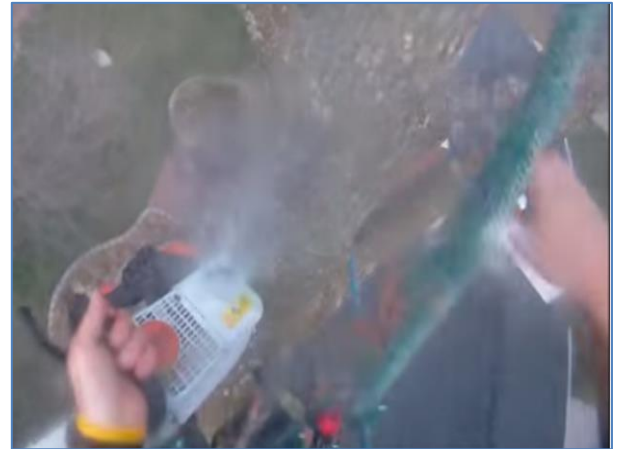
Screen Shot from Video – Shows a fuel geyser erupting from a chainsaw. (This photo is not from the Willow Peak Fire burn injury incident.)
