Rapid Lesson Sharing

Event Type: Dozer Rollover

Location: Shooting Range Prescribed Fire,
Talladega Ranger District,
Alabama

Lessons from a Dozer Rollover on a Prescribed Fire Assignment

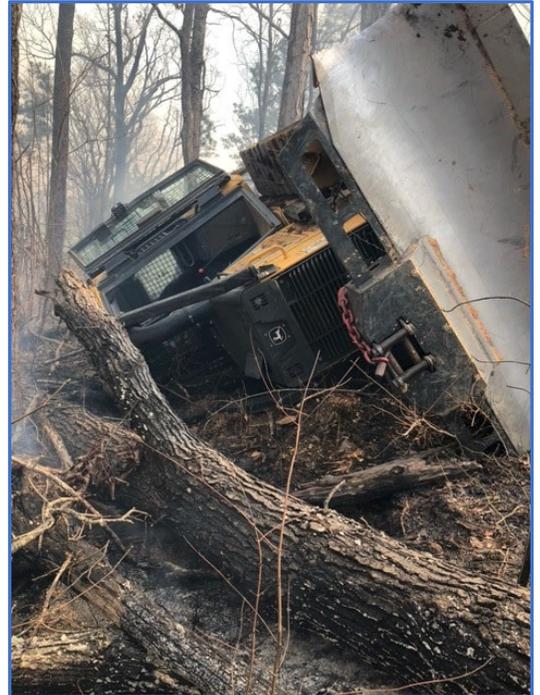
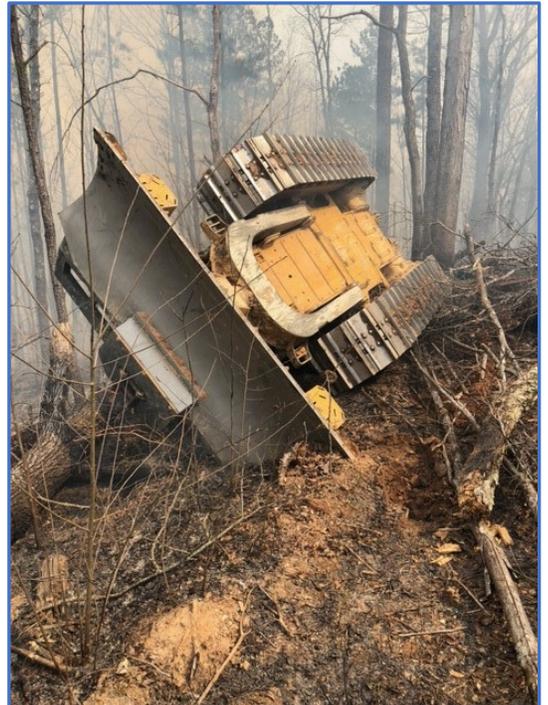
The falling branch tilted the machine to the right—downhill side—and the dozer began to roll slowly over and onto the ground, coming to rest on its right side.

After assessing the situation, the operator shut down the dozer's engine. Because his seat belt was located under his right side, the operator had some difficulty unbuckling the seat belt. After freeing himself, the operator exited the machine out the left door.

Both the dozer and operator seemed unharmed. The dozer operator called the Prescribed Fire Burn Boss (RXB2) and informed him of this incident. The dozer operator also called his supervisor.

They used two chains into D rings to slowly right the dozer. Next, to ensure that all the fluids were able to drain down, they let the machine sit for one hour. After this time period, the dozer was started. It appeared to be undamaged. They therefore walked the dozer to its transport.

- ❖ The operator was aware that his blade was not high in the air. But, as it turned out, the blade was also not low enough to have struck the downed logs instead of climbing up onto them. On this machine, the two storage boxes on the blade obscures the view of the bottom of the blade. This can cause the operator to think the blade is lower than it actually is.

- ❖ Know your equipment and adapt to the configurations so you can safely operate the machine.
