# Rapid Lesson Sharing

**Event Type:** Fuel Geyser Incident

**Date:** April 27, 2020

## Insights and Lessons from a Fuel Geyser Event

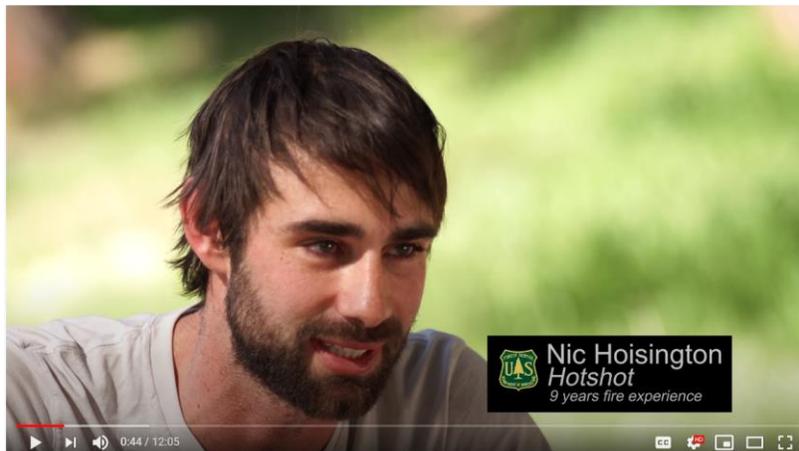
- ❖ **How to Avoid a Fuel Geysers:** <https://www.wildfirelessons.net/viewdocument/how-to-avoid-a-fuel-geyser>
- ❖ **National Fuel Geysers Awareness Website:** For more information—or if you experience a fuel geysers—go to the National Fuel Geysers Awareness website: <https://www.nwgcg.gov/committees/equipment-technology-committee/national-fuel-geyser-awareness>
- ❖ **Here's what can happen when a geysers happens on the fireline:**
