Stanza Fire Engine 11 Accident Investigation Report

Accident Investigation Factual Report

Accident: Stanza Engine 11 Investigation
Location: Happy Camp Ranger District, Klamath National Forest
Date: July 28, 2002

**Accident Investigation Factual
Report and Management
Evaluation Report**

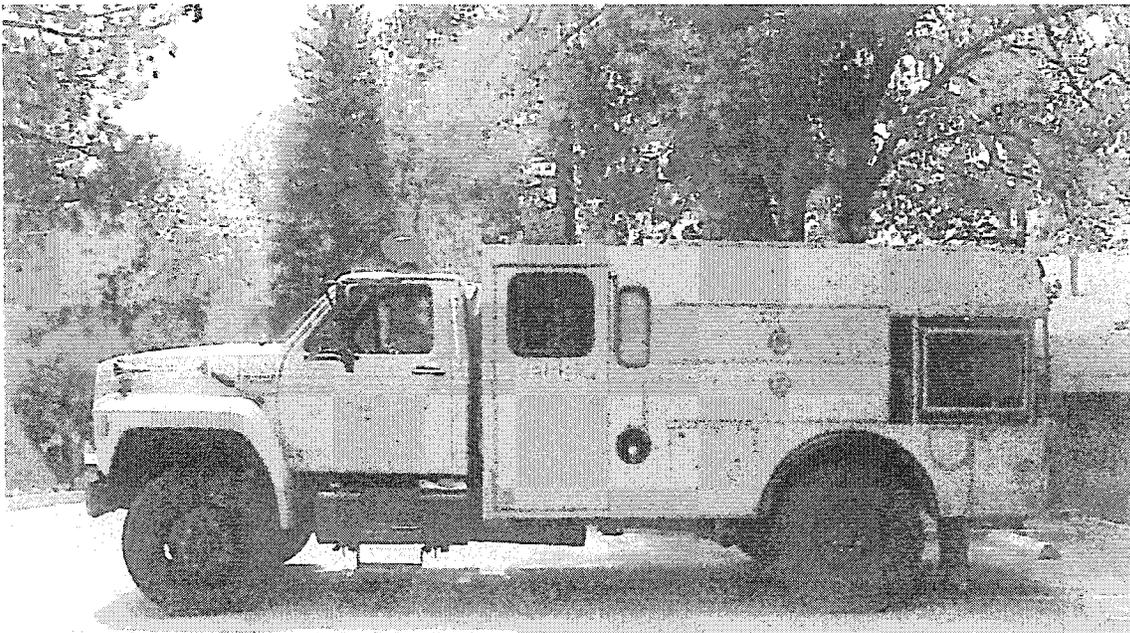
E-11 was a 1991 two-wheel drive Ford F-800 Model 61, Type III Fire Engine (Figure 2). It was equipped with a 6-cylinder diesel engine and a 6-speed manual transmission. It was comprised of a fire engine body (with a crew compartment that is designed as an integral part of the body), a 500 gallon baffled steel water tank, and utility type body compartments. Overall length of the truck was 22 feet, wheel base was 166 inches, and the width measured between the outsides of the rear dual tires was 93 inches. The width of the front tire track is approximately two inches less. For more information, see Specification Sheet in Appendix D.

Figure 2. A 1991 two-wheel drive Ford 800 Model 61, Type III Fire Engine.
This engine is the same model as E-11.

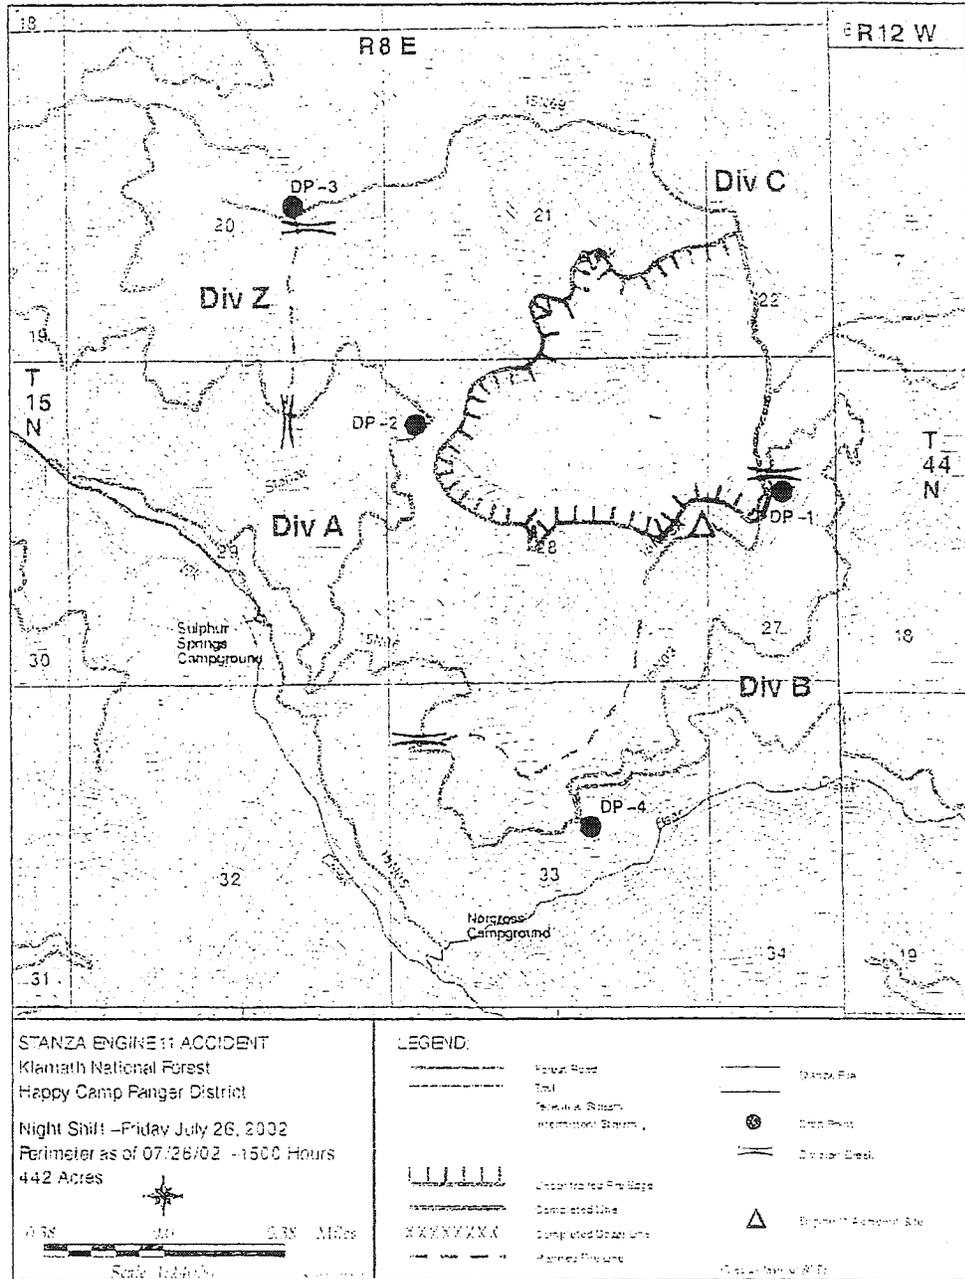
Figure 5. Stanza Fire Situation on July 26-27, with location of Road 15N03A relative to Drop Point #1.

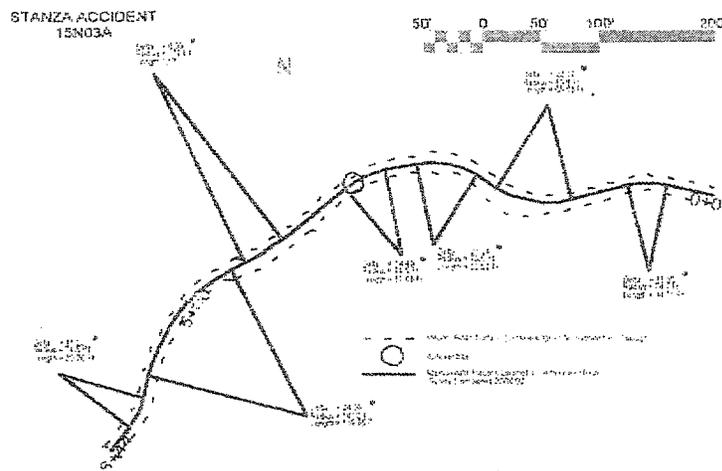
5. There was a slight curve at the rollover site on the drivers' side (outside slope). (15N03A Alignment Drawing, 8/4/2002 Figure 18)
6. There were several other curves on the 15N03A road with the same or nearly the same radius. (15N03A Alignment Drawing, 8/4/2002 Figure 19)

Figure 19. Road alignment schematic for 15N03A
