Rapid Lesson Sharing

Event Type: Engine Tire Fire

Date: June 18, 2016

Location: Deer Creek Fire, Wyoming

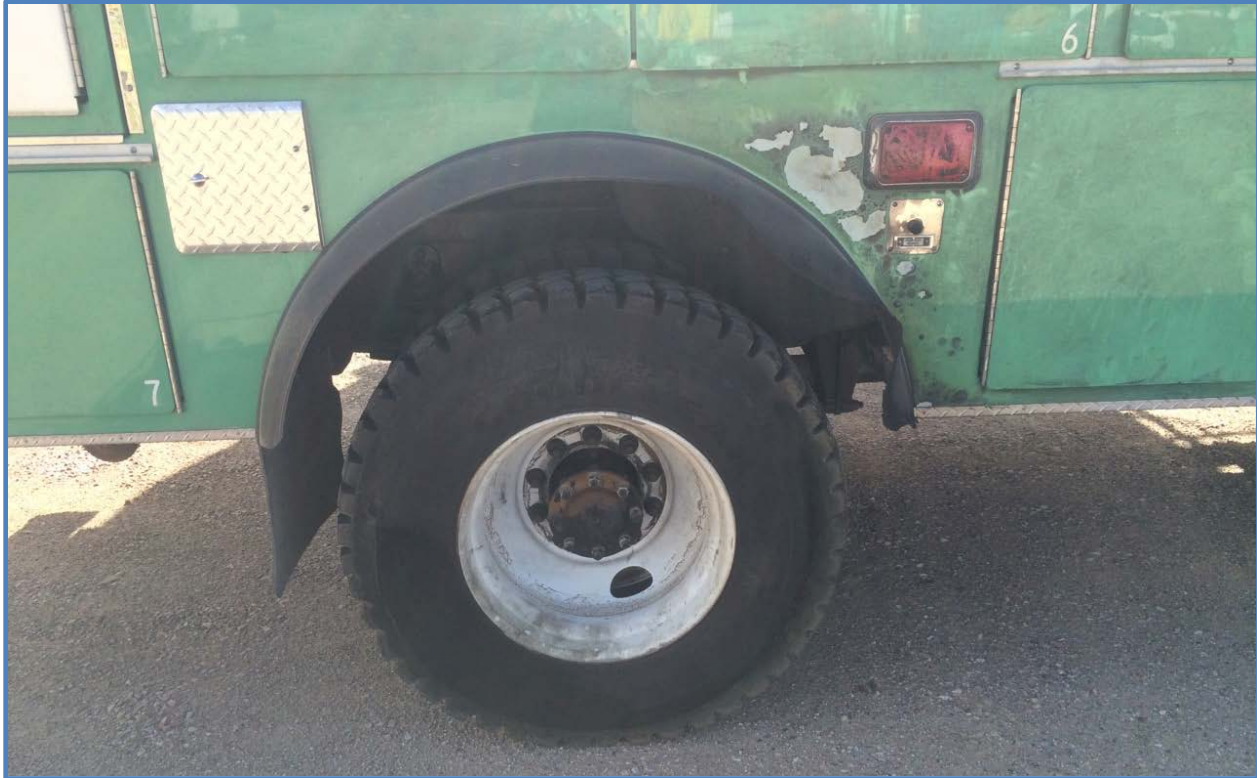
They discovered a hole in the brake air line located approximately three to four feet in front of the right rear axle in the middle of the frame. (Arrow points to where they patched the damaged line with electrical tape and zip tie.)

They heard a noise that resembled an air leak and decided to inspect the entire undercarriage. In doing so, they discovered a hole in the brake air line located approximately three to four feet in front of

Once they successfully moved the Type 4 into a safer, workable location, they began to assess the damage more thoroughly. At this time, they patched the air line using electrical tape, duct tape, and a large zip tie. This repair was adequate enough to build air pressure in the lines and allow them to safely drive the engine approximately three miles to a more suitable location on pavement where a tow truck could easily access and retrieve the Type 4.
