# GREEN SHEET

## Shelter Deployment with Burn Injury

Gold Incident

20-CA-LMU-003917

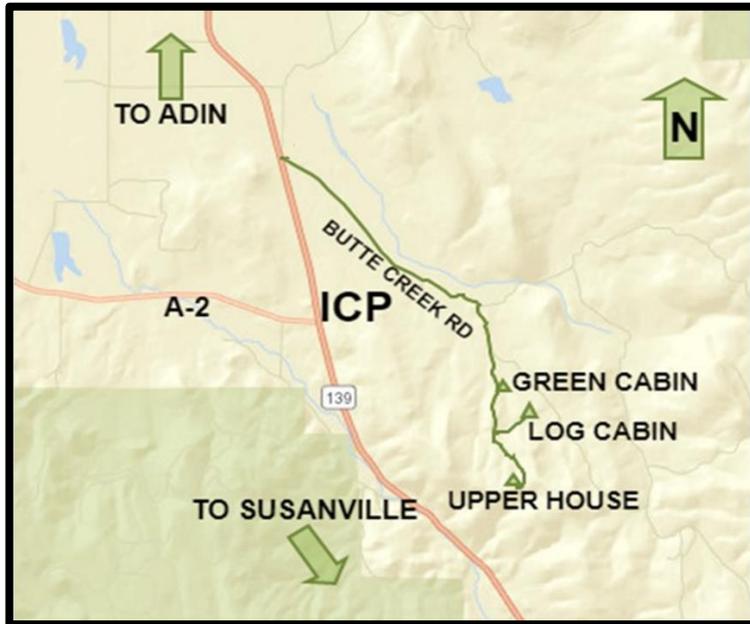
At approximately 3:40 PM, E4 traveled to the Upper House and E3 traveled to triage the Log Cabin. DIVS A followed E4 up to the Upper House.

At approximately 3:52 PM, E4 arrived at the Upper House and began assessing structure defense.

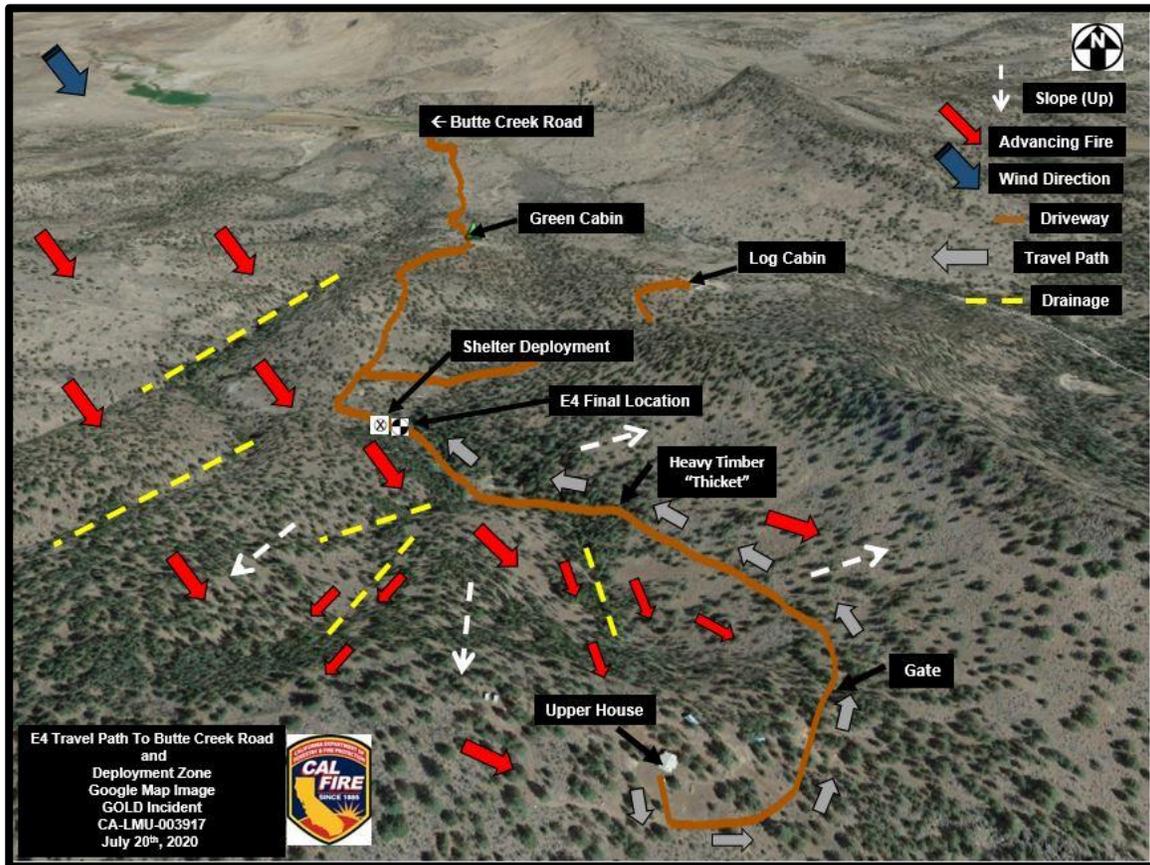
After securing their equipment, E4 left the Upper House. As E4 passed through the gate, they observed fire on both sides of the road. E4 had to slow to negotiate the first few water bars on the way down the steep narrow road.
