Informational Summary Report of Serious or Near Serious CAL FIRE Injuries, Illnesses and Accidents

GREEN SHEET

Fire Shelter Deployment

North Complex West Zone

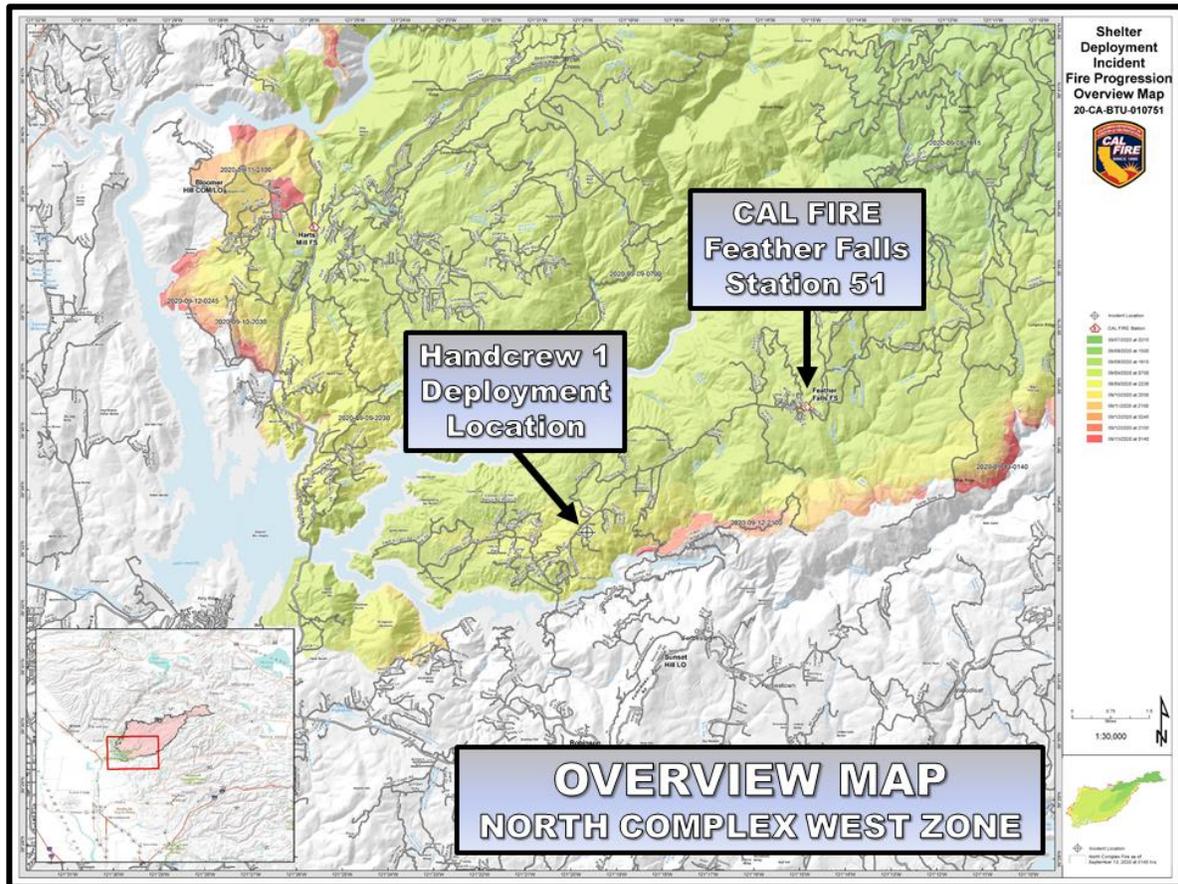
Photo & [Video](#) - Aerial overview of ECT, residential structure and deployment location. Burnout operations reduced fuel loading around house prior to fire front impact.
