Rapid Lesson Sharing

Event Type: Engine Burn Damage/Fire Behavior in Exceptional Drought

Engine Burn Damage Date: July 14, 2021

Engine Burn Damage Location: Log Fire, Oregon

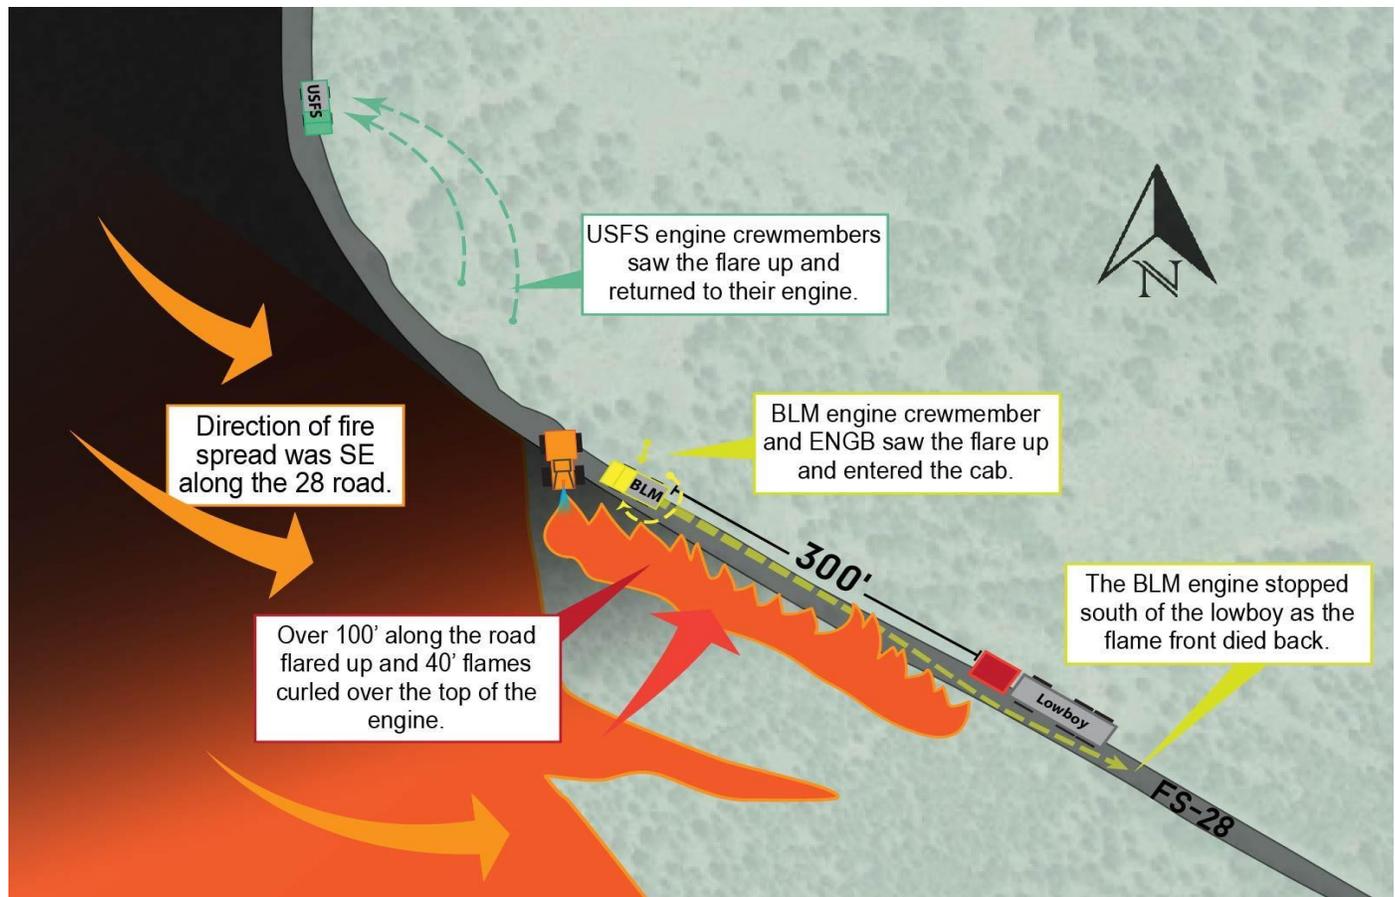
*"It got super hot
in the vehicle very quickly."*
Engine Driver

The engine's back passenger described the flames like a "cloud of fire coming around the engine" and said that it looked like liquid. "It got super hot in the vehicle very quickly," recounted the engine driver.

- ❖ Most plastic and rubber composite components on the driver's side melted to some degree from direct flame impingement. These damaged items include: trim molding, vehicle plug-in charging port, fender flare, diesel and DEF (Diesel Exhaust Fluid) caps, door handles, mirror assembly, and weather stripping. The following were discolored, blistered, and/or melted: lighting components including the driver's side headlight, marker lights, overhead scene light, and lightbar.
