Rapid Lesson Sharing

Event Type: Helicopter Rotor Strike

Date: July 8, 2018

Location: North Spring Fire, Colorado

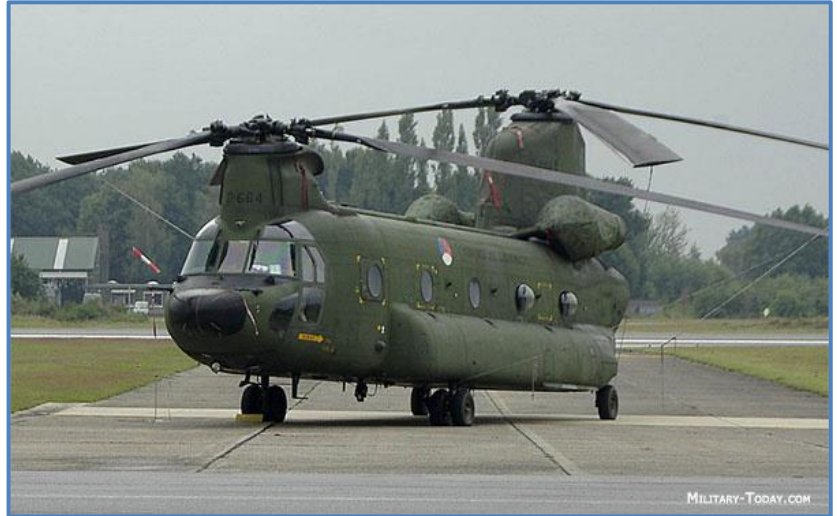
A Chinook Helicopter similar to the one on the North Spring Creek Fire incident.

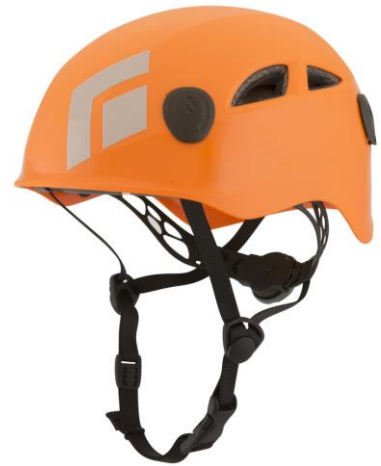
Similar helmet to the one being used by the Chinook Helicopter crew.

- ❖ Within the past year, the company has implemented a safety practice that requires all crew members climbing on the aircraft to wear safety helmets. Fortunately, the crew member during this accident was wearing the provided safety helmet which potentially prevented further injury.
