# LESSONS LEARNED

Northern Region Safety & Occupational Health

August 2010

## ATV GOING ON A RIDE WITHOUT RIDER

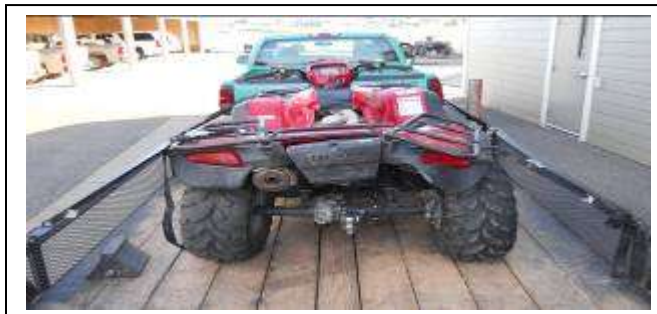
A trails crew seasonal was in the process of maintaining a portion of a trail. As he was riding to his work area, his ATV clipped the uphill side of the trail edge on a narrow portion of the trail. This tipped the ATV and it began to slowly roll over. The rider jumped off to the downhill side and attempted to stop the rolling motion. He quickly realized he could not stop the ATV and jumped away to the front side to avoid getting hit or pinned. The ATV gained momentum and continued rolling downhill approximately 60 feet before it came to rest upright on a ledge. The ATV, a six year old Honda Foreman 500, it was seriously damaged and will not be repaired. No persons were hurt or injury.

1. ATV was not in optimum condition. Frame had been previously welded (at least twice) and suspension was becoming loose.
2. Front tire alignment was off making steering more difficult.
3. Weather and fatigue were not factors. Conditions were sunny and dry, and rider was alert.
4. Speed, approximately 5-7 mph, was not a factor.

1. Ensure that equipment is in safe operating condition before attempting to use, red tag equipment until repaired or disposed of.
2. Consider trail conditions (narrow, steep, e.g.) before attempting to traverse with an ATV/UTV. Hike to destination if you need to.
3. Use alternative methods for trail maintenance if an ATV is not safe to use in that terrain.
4. Use only equipment that is in good condition.
5. Never weld frames.
