# Lessons Learned

## Icy Road vs. Forest Service Vehicle, Equals Rollover

**Incident Date:** January 14, 2010

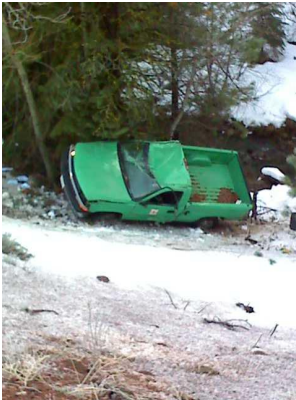
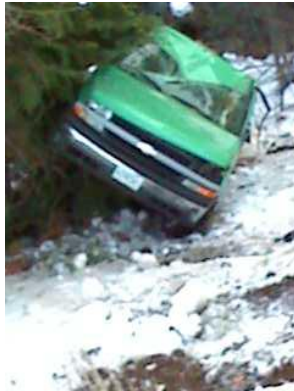
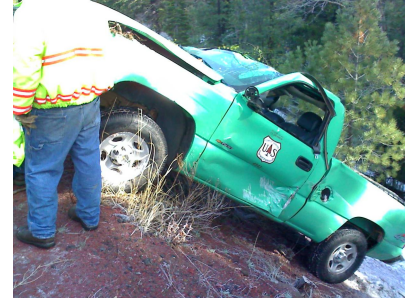
The accident was a result of the vehicle hitting a large patch (three highway travel lanes wide and about two hundred yards long) of icy road. Highway 36 at this location was covered from side to side with ice.

The vehicle went into a left hand spin and 270 degrees later was backing across the highway, across oncoming traffic, into the embankment on the opposite side of the highway. Vehicle maintained its speed of 35-40 miles per hour during the spin.

At the location where the vehicle hit the embankment (on the opposite side of the highway) with its rear wheels and bumper, the vehicle flipped end over (180 degrees) landed on the top of the truck cab, and then continued its flip end over (another 180 degrees) and continued to slide into/onto a tree at the bottom of the ravine (about 60 yards), stopping the truck before it entered "Willard Creek".

About 10 minutes later, here comes Vehicle #3 (our FS truck), spun-out and was the only vehicle that flipped (360 degrees) head over tails over the embankment and landed on its wheels, accident #3. Now everyone on scene responded to the needs and care of our FS Employee.

- Employee's must continue to wear seatbelts, they are the difference between serious and minor injuries;
- Employees must continue to keep all loose items in vehicle restrained and secure. We cannot allow items in the vehicles to become projectiles;
- Vehicle was traveling at posted speed limit, however, posted speed limits are not mandatory, we must drive for the condition we are exposed to;
- All employees need to be aware of road conditions, especially when freezing temperatures cause highways and surface roads to ICE over;
