Rapid Lesson Sharing

Event Type: Pile Burning

Location: Tiller Ranger District,
Umpqua National Forest, Oregon

Truck Gets Stuck in Snow Beside Burning—Threatening—Machine Pile

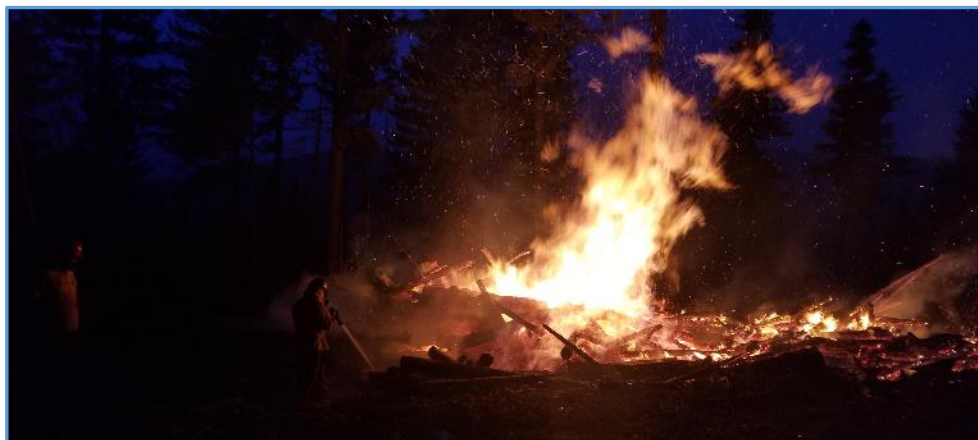
When the engine arrived at 1645 they sprayed 750 gallons of water on the pile.

The engine arrived a short time later. They sprayed 750 gallons of water on the pile, which slowed the progress and dissipated quite a bit of heat near the truck. The tow truck arrived a short time after that. They were able to successfully pull the truck out without it receiving any damage.

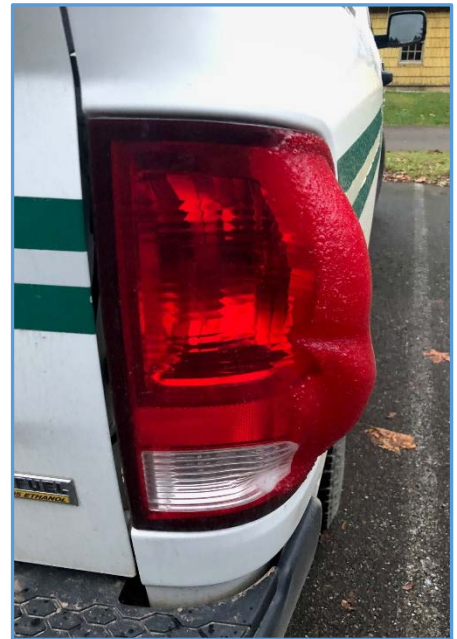
They then noticed that the side of the supervisor's truck facing the fire was starting to blister and having plastic begin to melt from the radiant heat. They disconnected the winch cable from the stuck truck and moved the supervisor's truck away from the landing pile fire.

The radiant heat damage to the supervisor's vehicle included: melted plastic on the passenger side rear brake light; mount around for the antenna; light bar; and bubbling and peeling of the vehicle's stickers.

Radiant heat damage to the supervisor's truck.

- ❖ Don't park next to a pile that you intend to burn.
- ❖ Make sure that all vehicles have the necessary tools.
- ❖ Be aware of possible damage from radiant heat.
- ❖ Communication issues with the district office.
- ❖ Due to location, the amount of time it took to get help to site.
