# Rapid Lesson Sharing

**Event Type:** Water Tender Rollover

**Date:** September 27, 2020

**Location:** August Complex South Zone,  
Mendocino National Forest,  
California

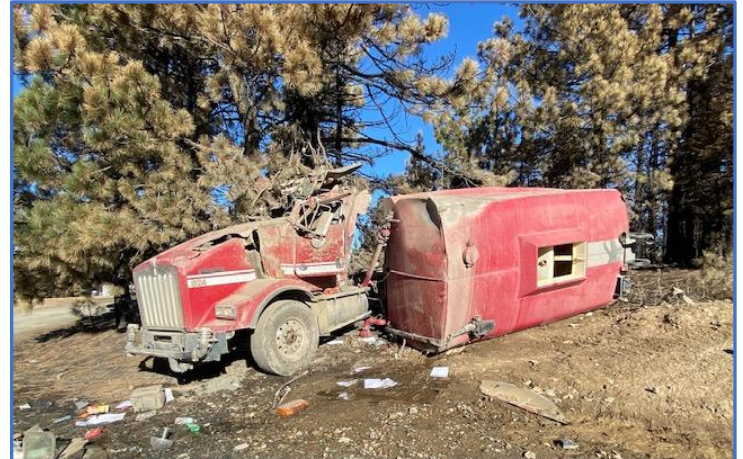
**Top Photo:** The Water Tender after the roll over.

A Safety Officer assigned to the incident arrived on scene, provided a size-up of the incident and assumed command of the IWI. When units arrived on scene, the Water Tender was upright, resting on its wheels against a tree with its tank separated from the chassis.

- Always take the time to put on your seatbelt. This should be a given because it is a state law, but in a rush to accomplish a task or when a task is short duration, clicking a seatbelt can get skipped. A properly worn seatbelt can reduce injuries during an unintended outcome.
- It is critical for any vehicle operator to keep vehicles at a reduced speed to the extent possible while vehicles are under heavy load driving on surfaces with increased stopping distances
- Beware of soft shoulders, narrow sections, blind corners, compromised visibility, and **distractions**—any combination of these conditions is especially dangerous.

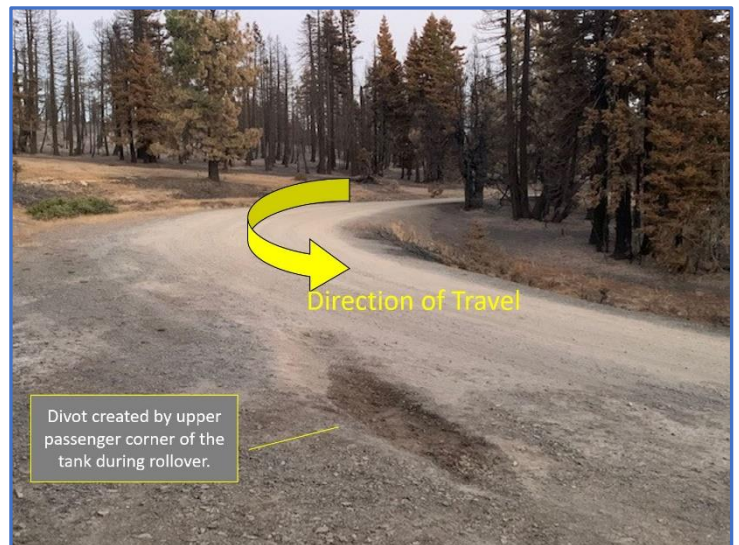
**Bottom Photo:** Shows the divot in the road created by the upper passenger corner of the Water Tender’s tank during the rollover.
