Rapid Lesson Sharing

Event Type: Vehicle Rollover

Date: July 16, 2018

Location: Aragon Fire, Santa Fe National Forest,
New Mexico

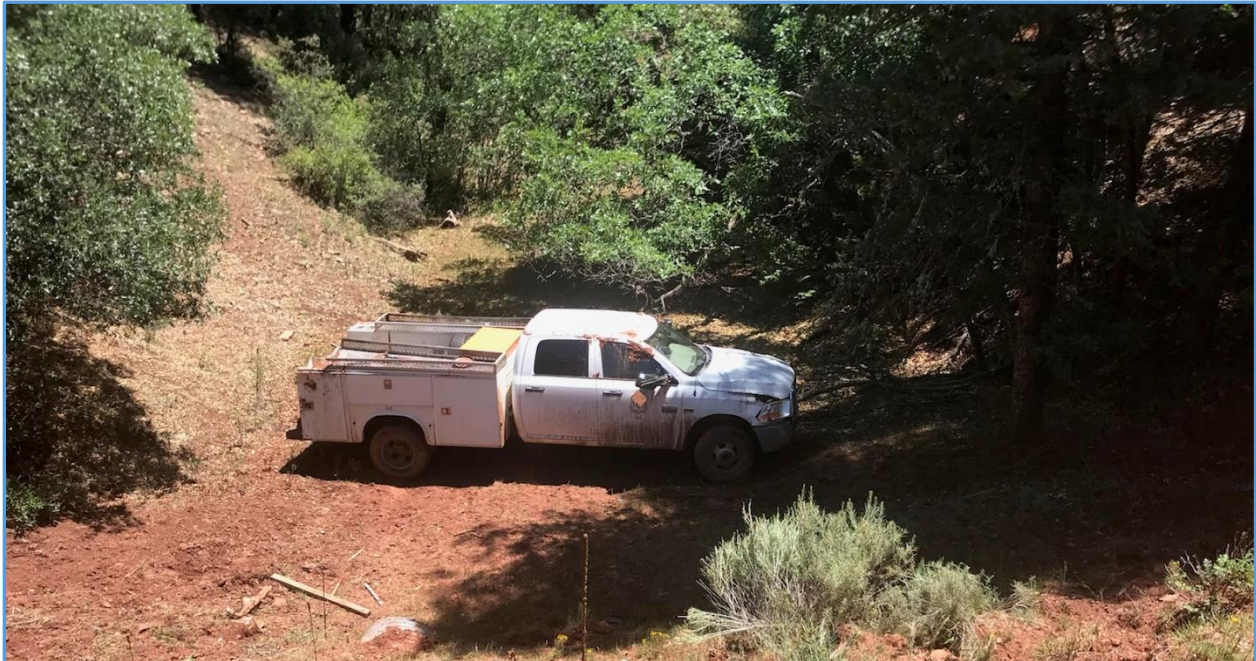
Truck #1168 in the bottom of the drainage where it came to rest after sliding off the road embankment and rolling over one time.

NFSR 505 contains a narrow section where the road is elevated above the natural drainage. Erosion had created a depression on the right side of the road in this narrow section.

The driver steered the vehicle to the left side of the road here to miss the eroded area. The vehicle began to slide off the road and over the embankment. The vehicle rolled completely over, coming to rest upright in the bottom of the drainage.

- ✓ UTVs were borrowed from other Districts to increase the number of people who could be carried into the fire to minimize the number of trucks being used for transport.
- ✓ All personnel going to the fire will have overnight gear with them. If it rains, they will spend the night on the fire and not drive out until the next day when the 505 road is dry.
- ✓ A Safety Officer (SOFR) was ordered for the fire.
- ✓ A Paramedic was ordered for the fire.
- ✓ A motor grader was brought in to smooth road 505 for better driving conditions.

- ❖ Evaluate how to mitigate potential hazardous road conditions each day of the incident. Do not lose sight of the reason for the mitigation.
- ❖ On roads that have a clay base, prepare for an overnight stay. Do not drive on the road until the next day when the road has dried out.
- ❖ When roads are slippery and muddy, pull over and put chains on the tires.
- ❖ Thunderstorms can form immediately overhead.
